6.10.3 The Four Cases

6.10.4 Characterization of the Fires

6.12.6 Characterization of the Thermal Profiles

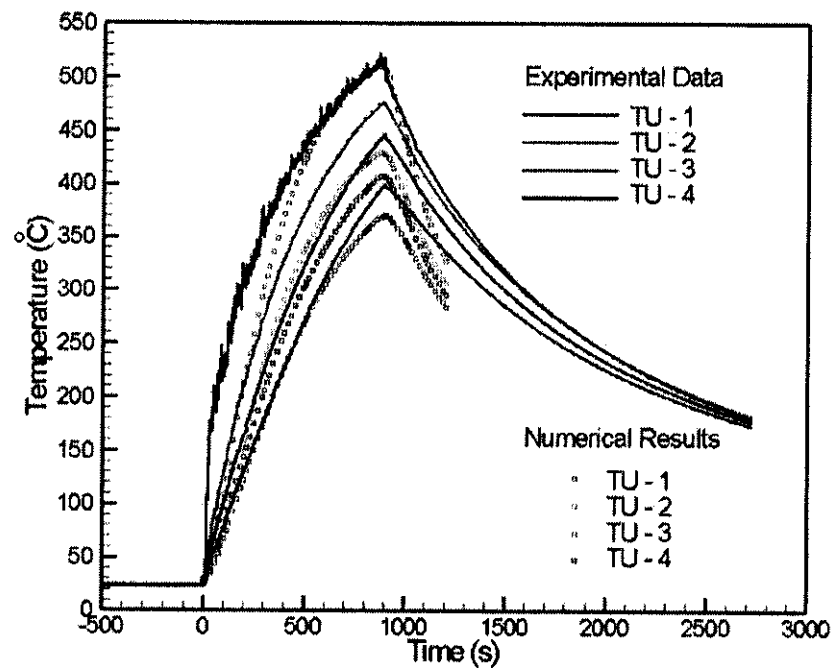
Figure 6-44. Comparison of numerical simulations with measurements for the steel surface temperature at four locations on the top chord of a bare truss.

Figure 6–44 compares the measured and predicted temperatures on the steel surface of the top chord of a bare truss. Figure 6–45 is the analogous plot of the measured and predicted temperatures on the steel surface of the top chord of a truss insulated with 3/4 in. of BLAZE-SHIELD DC/F. Similar curves were generated for each of the steel pieces, bare and insulated.
